# 3D TECHNOLOGY FOR MANAGING PAVEMENTS

## Abstract

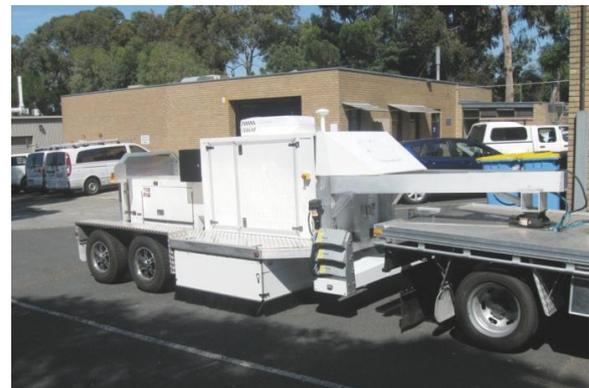
The RoadCrack system was initially mounted on a truck and was much larger than most common survey vehicles but in 2011 the system was modified and upgraded by ARRB so that it could be installed on a much smaller 5th wheel trailer platform which is shown in Figure 1.

Figure 1: RoadCrack system – new trailer version

One of the main benefits of the RoadCrack system is that it can generate cracking outputs in real time whilst travelling at highway speed. This alleviates the need to store large volumes of imaging data for post-processing and it also means that the cracking results are immediately available at the end of each survey run. To achieve this outcome, the system relies upon a powerful lighting system and specifically developed crack identification algorithms.

Whilst being suitable for rural road networks and major arterial roads, the size of the RoadCrack vehicle is still significantly larger than a typical survey vehicle and does not lend itself to local road surveys especially in urban environments. This is an area where 3D systems have a significant advantage.

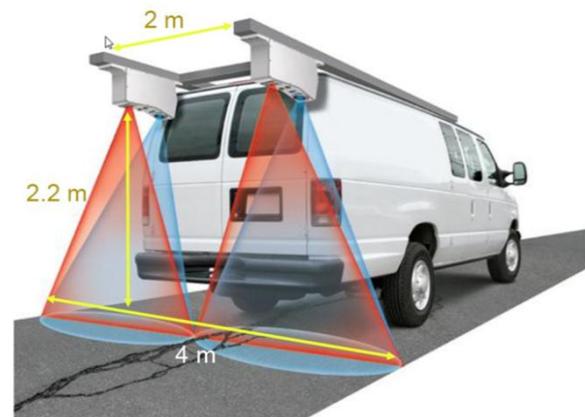
The ACD comprises two high-performance 3D laser units that are fitted to the rear of the survey vehicle, 2.2 m above the pavement as shown in Figure 2. Each unit consists of two main components: a high-power spread line laser and a high-speed 3D camera mounted off-axis to the laser light source. When combined, the two 3D laser units project a 4 m wide laser line consisting

of over 4,000 measurement points onto the pavement. Half of the image is captured by each camera which interprets the distortions to the straight laser line as variations in the vertical surface profile. Because of the high pixel resolution, measurement accuracies of 0.5 mm are claimed.

Figure 2: Configuration and measurement range of ACD (picture courtesy of Pavemetrics)

A picture of the road surface can be built up by combining sequential transverse profiles which, at 90 km/h, are only 5 mm apart (less at lower speeds). The LCMS sensors produce both range and intensity profiles which are merged to produce a 3D image. The information contained in this image allows the ACD system to automatically identify cracks and a variety of defects.

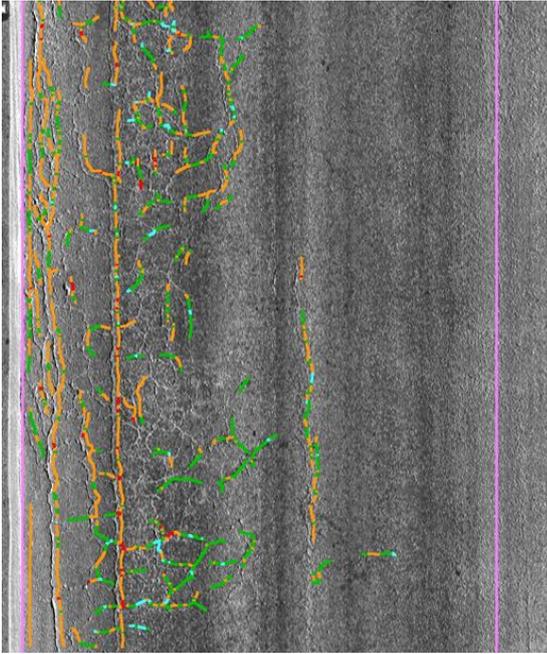
Figure 3: Example of crack map overlaid on 3D image

The variation in the colour gives an indication of the average width of each crack. In Figure 3, the largest cracks are shown in red, the smallest in light blue. The pink lines indicate the area in which the cracking is analysed and are automatically determined based on the presence of the more reflective line markings.

As shown in Figure 3, the 3D system is capable of producing a high-resolution picture of the road surface in which cracks and other defects are readily identifiable. However, like most automated systems, the LCMS isn't perfect and some of the fine cracks can be missed especially if 'pumping of fines' is evident. This can be improved by modifying the analysis algorithms.

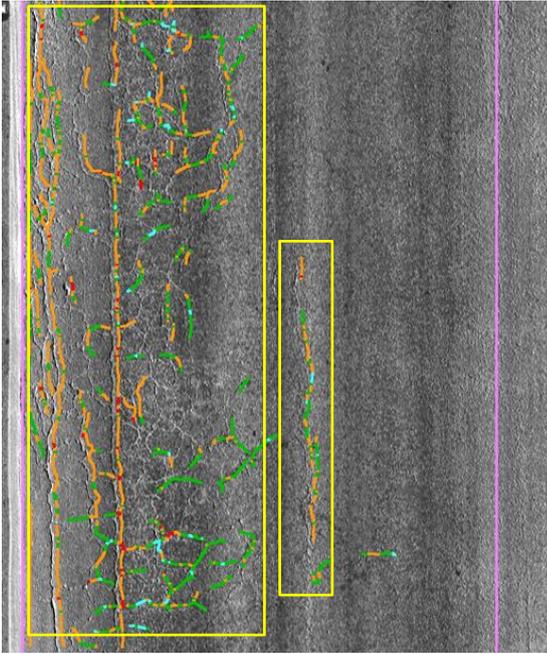
As shown in Figure 4, the resolution of the images is sufficient to identify the crack type and, because the image is calibrated, the extent of cracking can be accurately measured in both the longitudinal and transverse directions. 3D systems can also measure crack width which allows the severity of the cracking to be determined.

Figure 4: Example of crack type identification

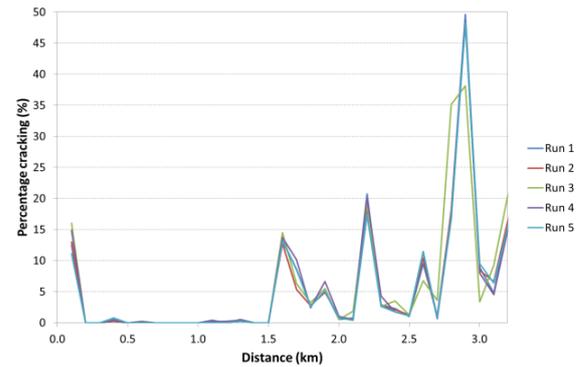
The ACD has been extensively trialled by ARRB. Its repeatability and reproducibility was tested over numerous test sites with asphalt, concrete and spray seal surfaces. An example of the level of internal repeatability that can be achieved with the ACD is shown in Figure 5.

Figure 5: ACD repeatability on dense graded asphalt

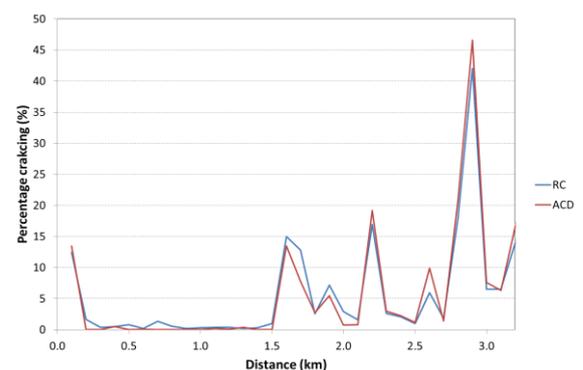
The ACD outputs were then compared against the results recorded by the RoadCrack vehicle over several test sites. As shown in Figure 6, the two systems were found to have a high correlation.

Figure 6: Comparison of ACD and RoadCrack outputs on dense graded asphalt

However, it should be noted that some differences between the two systems did occur, particularly on sprayed seal surfaces.

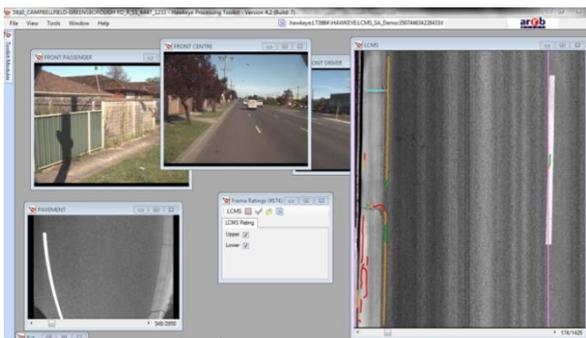
To assess the accuracy of the results, each image was also visually checked by a rater and any discrepancies were noted. This cross-checking highlighted several instances where the ACD was reporting false positives, i.e. a crack was being reported when there was none. For example, Figure 7 shows an example where the joint between the pavement surface and the kerb was being incorrectly reported as a crack.

Figure 7: Example of a false positive (joint between kerb and pavement in far right image)

This information has been fed back to the manufacturer and was used to modify the crack reporting algorithms. As the ACD continues to be used and further feedback is received, it is expected that the number of false positives will be reduced to an acceptable level.

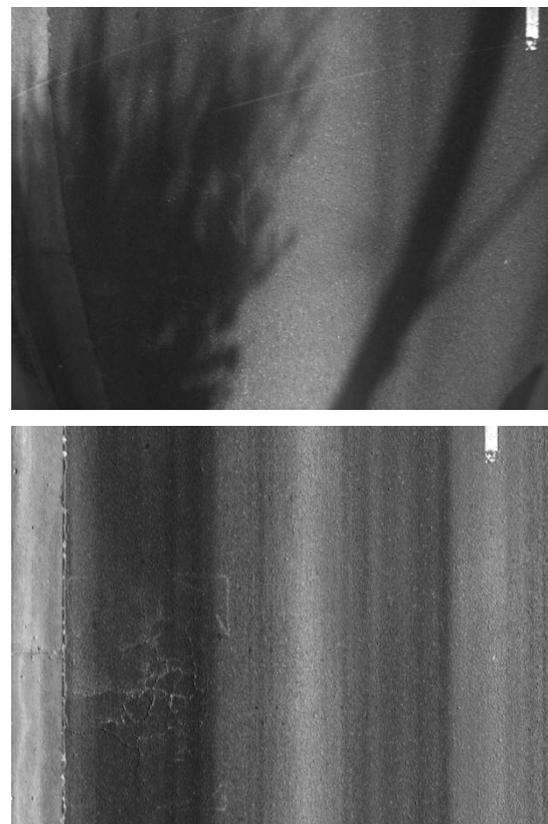
A comparison of the images recorded by the ACD and a standard digital imaging system using natural lighting in shadowy conditions is shown in Figure 8.

Figure 8: Comparison of outputs in shadow (2D camera above, 3D camera below)

As shown in Figure 8, the 3D images are also unaffected by lens distortion but more importantly 3D systems measure an extra dimension – depth – which can be used to identify various pavement surface condition parameters in addition to cracks. These include the following:

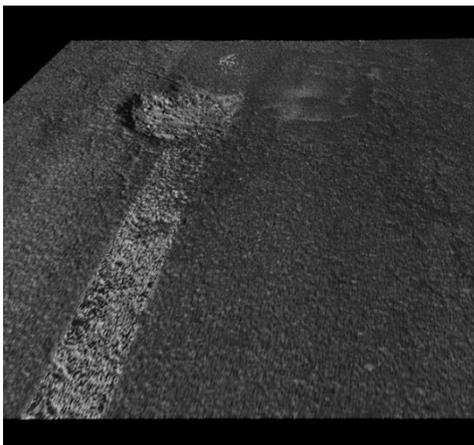
- Rutting – rutting is determined from the transverse profile which comprises more than 2,000 measurement points in each 2 m wheel path. This equates to a 1 mm transverse resolution which is significantly greater than the current point laser systems which typically have up to 15 lasers. The rut depths are recorded every metre and averaged to give a single value for either a specified interval or for a complete road section. The software can also limit the analysis to the trafficable width of the pavement as the 3D systems have the ability to identify line marking and edge drop off.
- Potholes and delamination – a 3D system can locate potholes and delamination and by measuring their depth and diameter calculate their area and volume. This enables the accurate calculation of fill material required for pavement rehabilitation. Figure 9 shows an example of a pothole identified by the ACD.

Figure 9: 3D image of a pothole (picture courtesy of Pavemetrics)

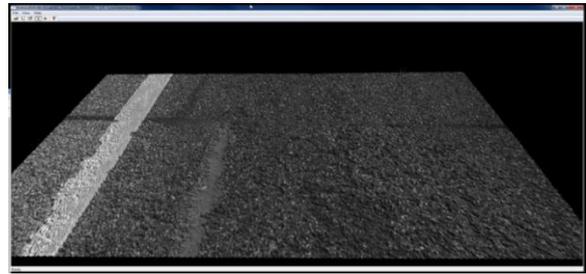
- Ravelling – this is defined as the ‘progressive disintegration of the pavement surface by loss of both binder and aggregates’ (Austroads 1987). The ACD identifies ravelled surfaces by calculating the volume of aggregate loss over

the area. The 3D picture shown in Figure 10 shows an example of ravelling identified by the ACD.

Figure 10: 3D image of ravelling produced by ACD (picture courtesy of Pavemetrics)

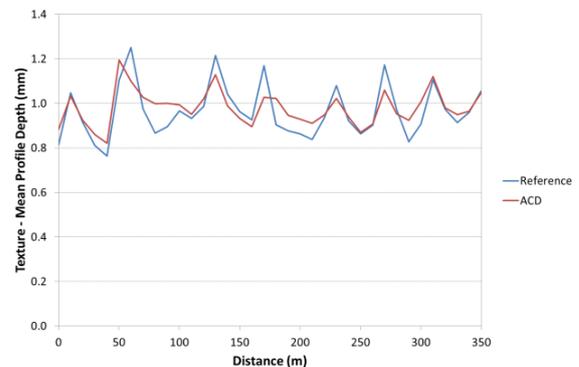
- Surface texture – a laser profiler usually measures macrotexture longitudinally over the pavement. However, there is no reason why macrotexture cannot be measured in the transverse direction also using a 3D system. The ACD meets the sampling requirements specified in the relevant Austroads guide for measuring pavement texture (Austroads 2011). The texture outputs of the ACD have also been compared against other texture measuring devices with good results. An example of the correlation between the ACD and a reference device is shown in Figure 11.

Figure 11: Texture comparison between ACD and reference device
