1 **Feasibility Study of Measuring Concrete Joint Faulting Using 3D Continuous Pavement**
2 **Profile Data**

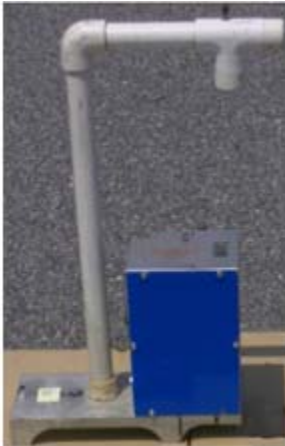
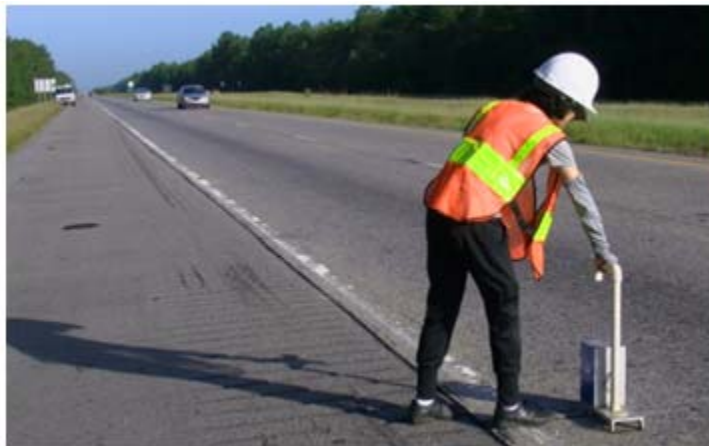
24 (a) The Georgia fault meter

25 (b) Manually measure faulting on the roadway

26 **Figure 1 Manually collecting faulting data using the Georgia fault meter.**

11 Manual methods have been used to collect faulting data. The Georgia fault meter,
 12 designed by the Georgia Department of Transportation (GDOT), is one of the most popular
 13 hand-held devices used by many state highway agencies, including GDOT (4) and the Minnesota
 14 Department of Transportation (MnDOT) (5). The surveyor sets the fault meter at a single spot
 15 along a designated joint with the lag on the departure slab and the measuring probe contacting
 16 the approach slab, as shown in Figure 1. For example, GDOT requires the meter to be set
 17 approximately 15 cm (6 inches) from the pavement edge marking in the outside lane. The
 18 surveyor pushes the button to acquire a faulting measurement and records it manually. However,
 19 this manual operation is labor-intensive, time-consuming, costly, and dangerous to both the
 20 surveyors and drivers. Thus, the manual survey is often conducted only on sampled joints and

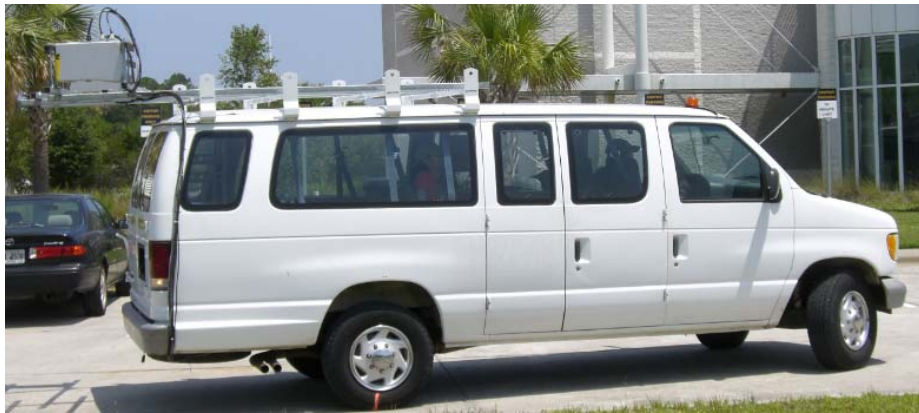
Figure 2 The sensing van for collecting faulting data.

22 This section presents the 3D continuous pavement profile data acquired using Georgia Tech's
23 sensing system integrated with emerging laser technology that can collect faulting data at
24 highway speed. The integrated sensing system includes a full-size van equipped with a laser
25 crack measurement system (LCMS) and a high resolution distance measurement instrument
26 (DMI), as shown in Figure 2. The LCMS sensors are mounted on the back of the van to acquire
27 3-D continuous transversal profiles, and the high resolution DMI is mounted on the rear wheel to
28 control the interval between two consecutive transversal profiles. The LCMS sensors are
29 designed to have a tilt angle to the transversal direction, so they can collect the faulting on the
30 transverse joint. This design is to prevent the acquired profiles from aligning with the transverse
31 joints. Designed at a 12-degree clockwise tilt angle and a 1-mm (0.04-inch) resolution, the

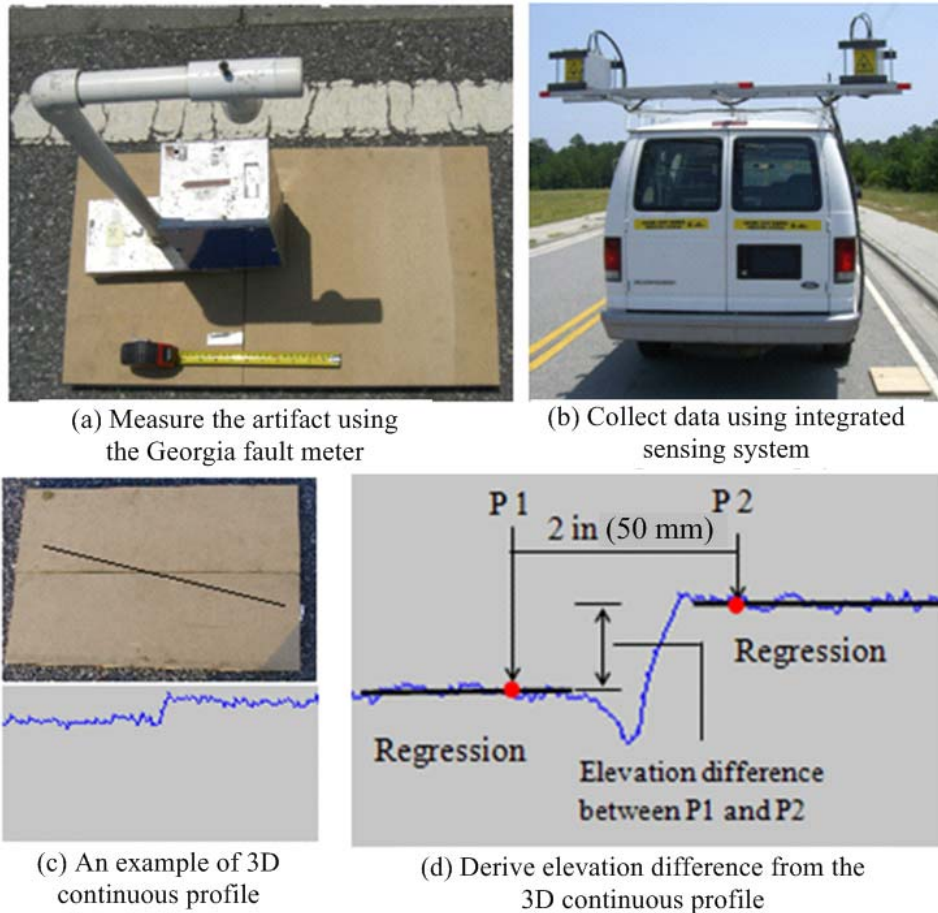
Figure 5 Controlled field test for measuring known elevation differences.

19 Controlled field tests were designed to evaluate the accuracy and repeatability of the elevation
 20 difference derived using the proposed method in a well-controlled environment. The artifacts,
 21 made of two wood panels creating two flat surfaces with known elevation differences, were used
 22 to test the proposed method. The elevation differences range from 1/32 to 19/32 inches, which
 23 are the ranges in the Georgia fault meter. The artifacts were set level on a fairly flat road on the
 24 Georgia Tech campus to ensure a consistent elevation difference between any two points on the
 25 two panels. The known elevation differences were also confirmed by using the Georgia fault
 26 meter on the test site, as shown in Figure 5(a). The integrated sensing system was then used to
 27 collect 3D continuous pavement profile data with a 1-mm (0.04-inch) resolution in the transverse
 28 direction and a 4.6-mm (1.8-inch) interval (space between two profiles) at low speed, as shown

29 in Figure 5(b). With a 12-degree tilt angle design, approximately 17 profiles were collected along
 30 the 38-cm (15-inch) wide wood panel. Figure 5(c) shows one of the 3D continuous pavement
 31 profiles that can be used to derive the elevation difference. The elevations of the two flat surfaces
 32 can be established by applying regression to the points representing the surface, as shown in
 33 Figure 5(d). Following the footprint of the Georgia fault meter, the elevations of two
 34 measurement points (P1 and P2 in Figure 5(d)), separated by 50 mm (2 inches), are estimated
 35 using the regression lines, and then the elevation difference can be calculated.

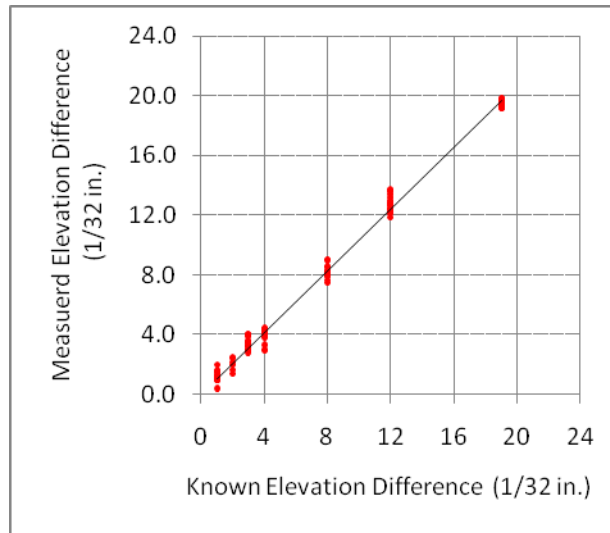
Figure 6 Known elevation differences vs. derived elevation differences.

1 by comparing the derived and the known elevation differences. Figure 6 shows the derived
 2 elevation differences are close to the known elevation differences with small variation. Table 1
 3 summarizes the comparison. The average absolute differences are within 1 mm (0.04 inches),
 4 and the variances are fairly small (less than 1 mm) and consistent across various elevation
 5 differences. It is noted the derived faulting measurements are slightly higher than the known
 6 elevation differences. The 1/32-inch (0.8 mm) elevation difference may not be detected reliably
 7 because of the resolution. The results of controlled field tests have demonstrated the proposed
 8 method can achieve a desirable 1-mm accuracy required in AASHTO R 36-04 and reasonable
 9 repeatability for measuring elevation differences.

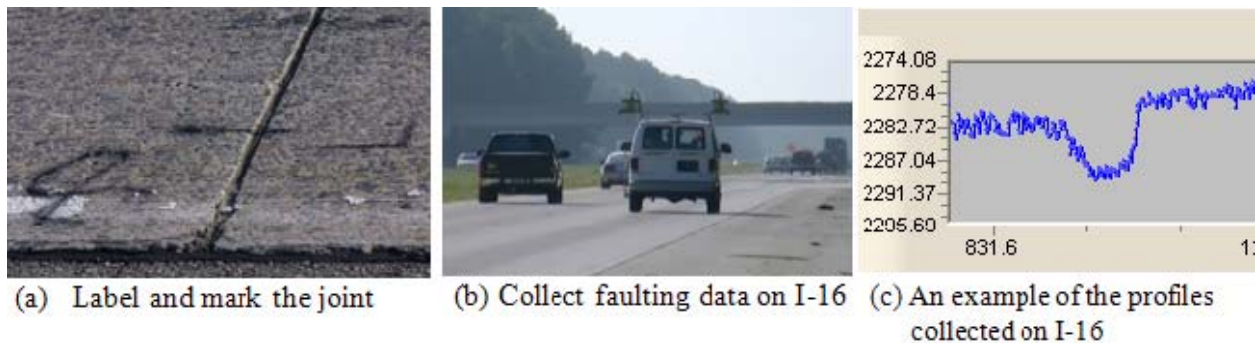
9
10
11
12 **Figure 7 Field test conducted on I-16.**

16 faulting data at two different highway speeds, 100 km/h and 80 km/h (62.5 mph and 50 mph), as
17 shown in Figure 7(b). Figure 7(c) shows an example of the profiles collected on I-16. It is clear
18 that the joint can be captured by the 1-mm (0.04-inch) resolution profile. Three runs were
19 repeated at each speed to evaluate the repeatability of derived faulting measurements and the

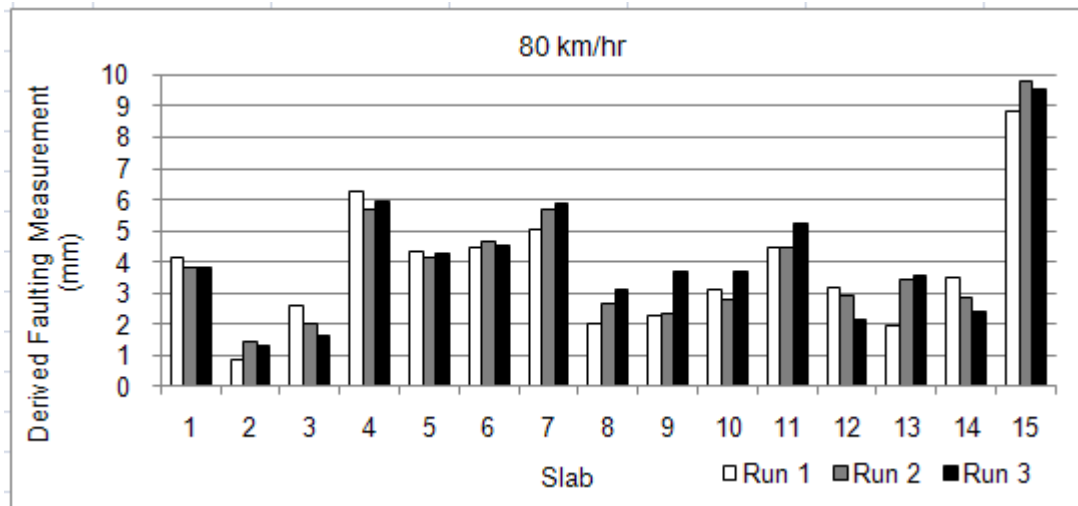
Figure 8 Derived faulting measurements at 80 km/hr.

13 Faulting measurements of the 15 joints derived using the proposed method was used to
 14 evaluate the repeatability of the derived faulting measurements and the feasibility of operating
 15 the system at highway speed. Table 2 summarizes the derived faulting measurements on the 15
 16 joints collected on I-16 at different speeds. The derived faulting measurements range from 1.2
 17 mm to 9.4 mm (0.05 inches to 0.37 inches). First, the repeatability of the derived faulting
 18 measurements collected in three runs at each speed is evaluated. Figures 8 and 9 show the
 19 derived faulting measurements from three runs at 80 km/hr and 100 km/hr, respectively. There is
 20 no significant difference observed among different runs. The standard deviations are within 1
 21 mm, as shown in Table 2. The maximum differences among three runs are also reviewed. For the
 22 data collected at 100 km/hr, 13 out of 15 joints (87%) have a max difference less than 1 mm

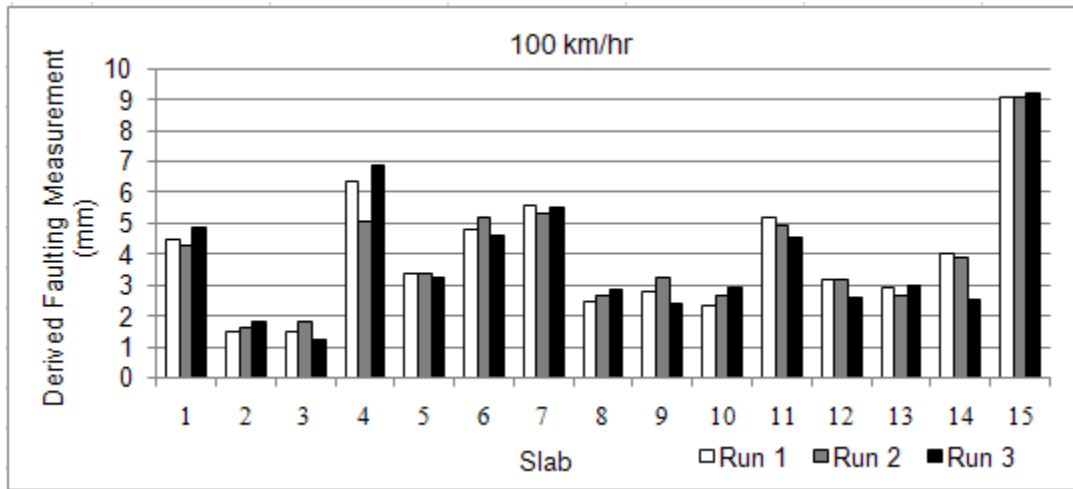
Figure 9 Derived faulting measurements at 100 km/hr.

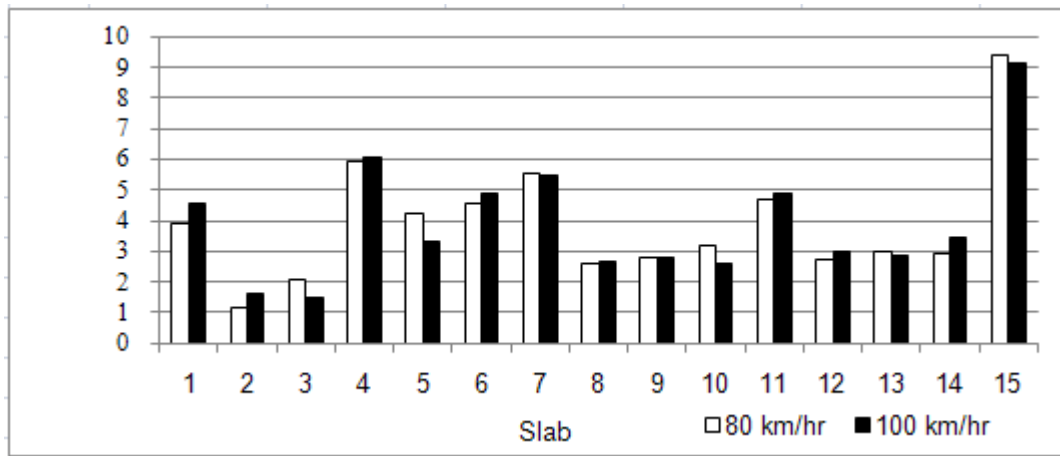
Figure 10 Comparison of faulting measurements at different speeds.

23 (0.04 inches). Results indicate the derived faulting measurements can achieve a desirable
 24 repeatability among different runs at the same speed. Second, the derived faulting measurements
 25 are compared at different speeds. Figure 10 shows the derived faulting measurements are fairly
 26 close at different speeds. The differences are within 1 mm (0.04 inches), as shown in Table 2.
 27 Based on the analyses, the proposed method can achieve a desirable repeatability among
 28 different runs and at different speeds, and it is feasible to operate the integrated sensing system at
 highway speed (e.g. 100 km/hr) for collecting faulting data.
