# AUTOMATED RAVELING INSPECTION AND MAINTENANCE PLANNING ON POROUS ASPHALT IN THE NETHERLANDS

**FIRM15 - Brussels**

- › Willem van Aalst, TNO
  - › System engineer & project manager (infra inspection)
- › **Automated raveling inspection and maintenance planning on porous asphalt in the Netherlands**

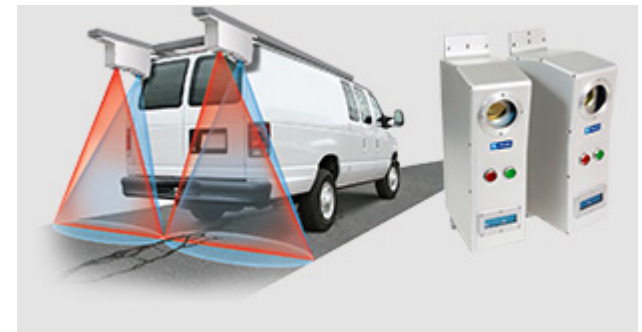
LCMS system

- › Simulation of measurement systems
- › State of the art systems:
  - › Laser triangulation (1 or 2 spots)
  - › Laser triangulation (2 lines)
  - › Amplitude phase modulation lasers
- › Selected: line laser triangulation
  - › LCMS sensors (INO/Pavemetrics)

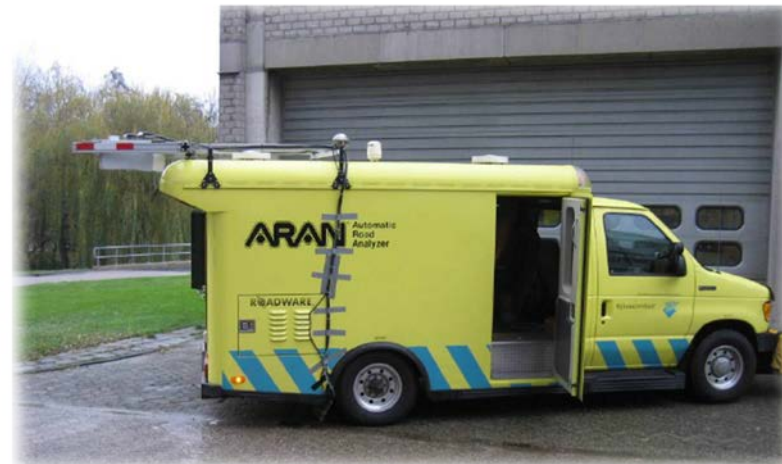
*RWS ARAN 2 equipped with the LCMS system*

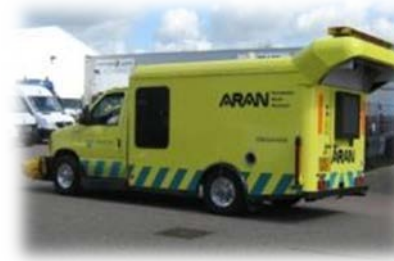
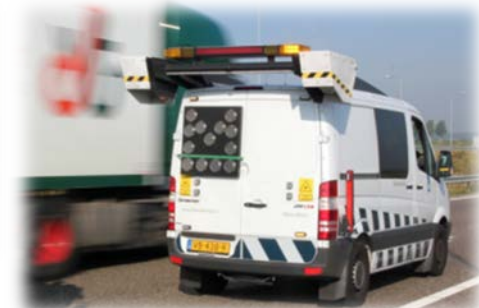
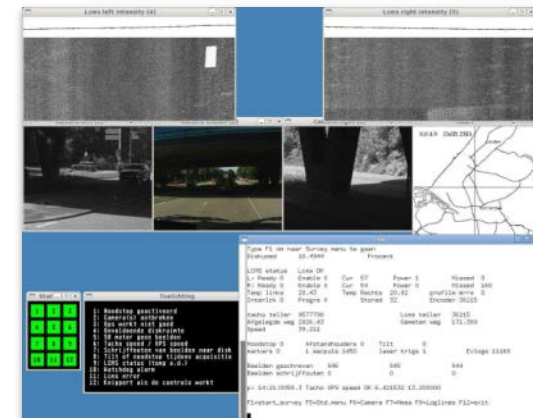
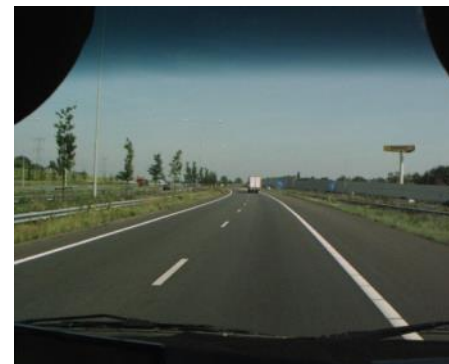
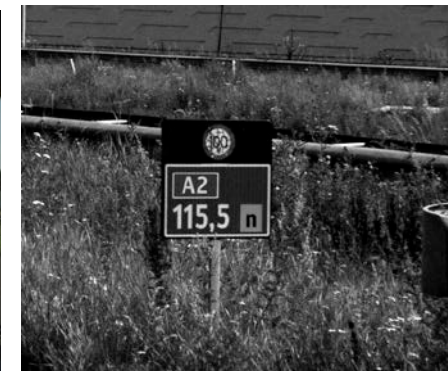
- › LCMS sensors & controller (3D data)
- › Laser Safety Controller (tilt, speed, ...)
- › RTK – GPS (positioning)
- › DMI (triggering)
- › Front- & side camera's (reference)
- › FPGA framegrabber (HW timing)
- › Acquisition pc (Windows)
- › Control pc (Unix)

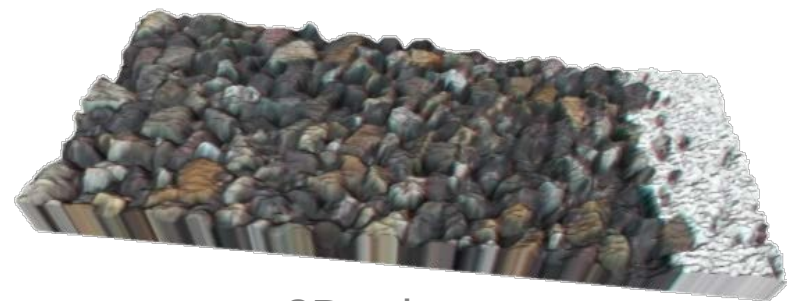
3D print

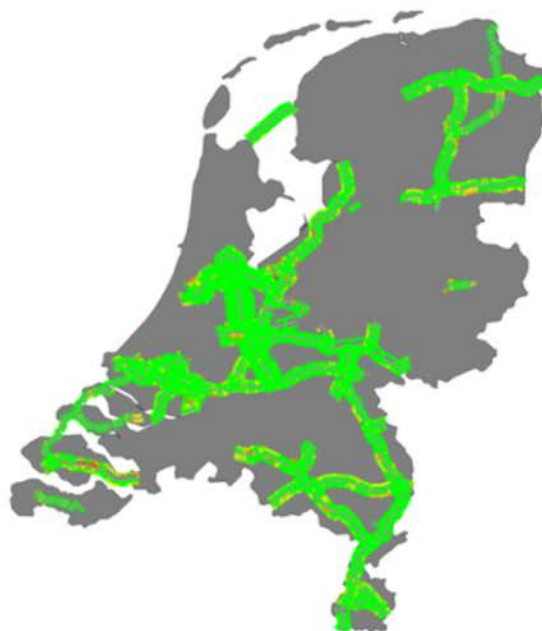
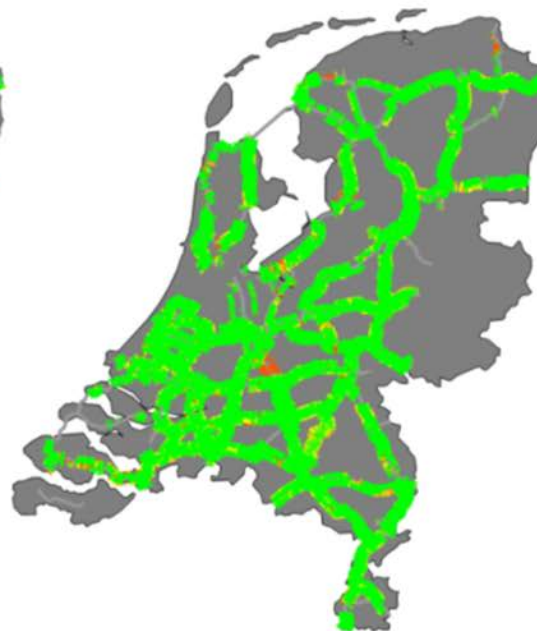
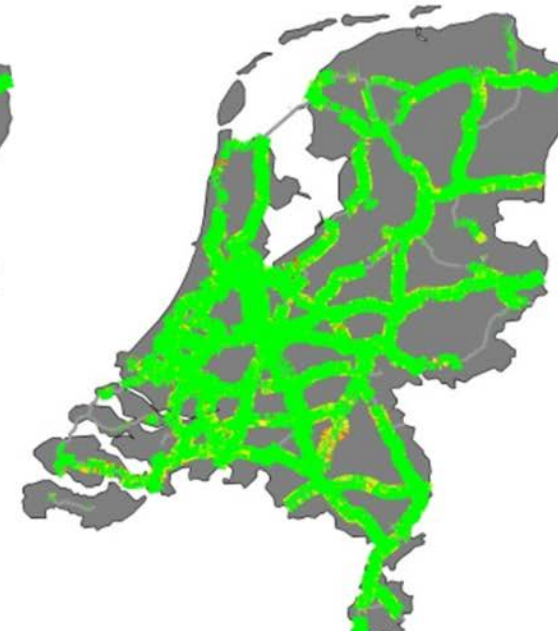
2012

2013

2014
