THE AUSTRALIAN 3D ROUGHNESS EXPERIENCE

Richard Wix

ARRB Group Ltd, 500 Burwood Highway, Vermont South, 3133, Australia

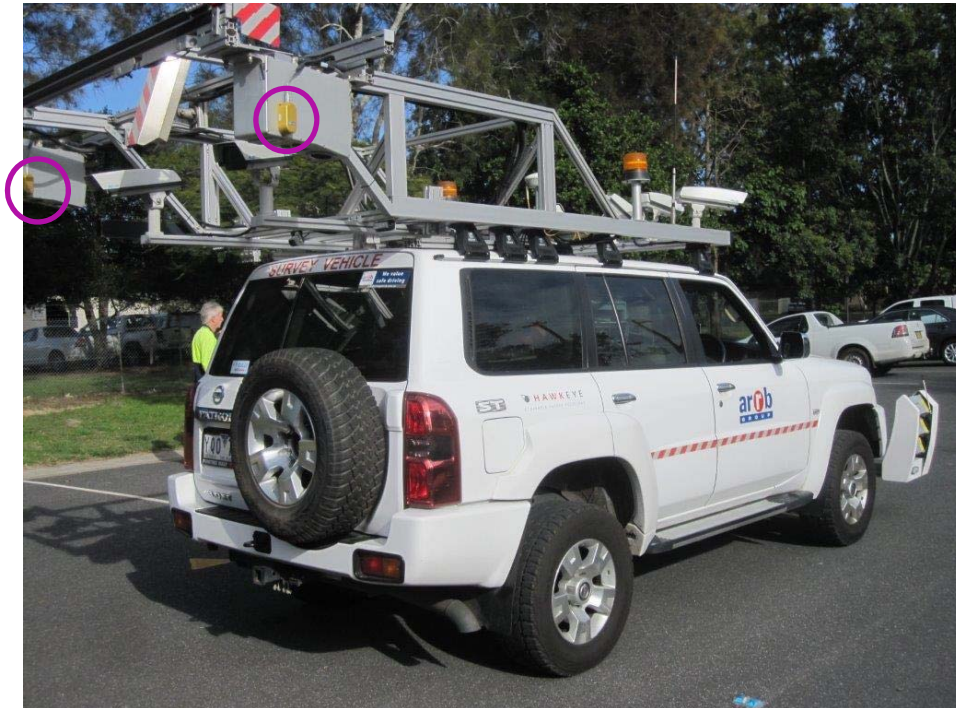
To overcome this shortcoming each sensor was fitted with an accelerometer, as shown in FIGURE 1.

FIGURE 1 3D system with additional accelerometers (circled).

Combining the output of the accelerometer which determines the inertial frame of reference of the 3D system, with the height of the ground relative to the accelerometer (measured using the sensor spot directly under the accelerometer), and sampling both together at a constant interval, allows the longitudinal profile of the pavement to be measured (2). In this way the 3D system operates in exactly the same way as a typical inertial laser profiler.

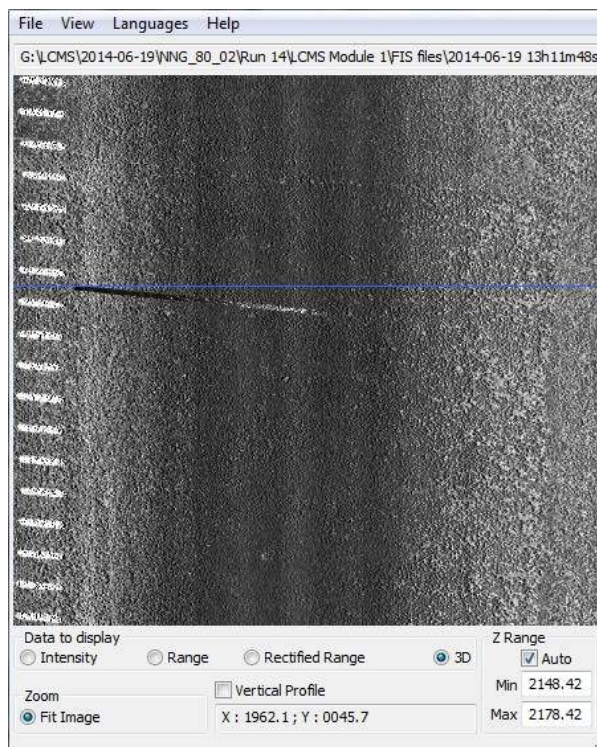
Black tape was placed on the pavement to accurately identify the start and end of each of the test sections. This is shown in FIGURE 2. This was essential as the processing software for the 3D system required the manual entry of the start location and the length of the survey. In contrast, the DLP was fitted with an auto trigger which detected reflective tape on bollards set up alongside the road (in line with the black tape) thereby identifying the start and end points. This removed the need for the operator to manually input the start and end points and possible introduce a misalignment in the data. The two test sites were surveyed in June 2014.

FIGURE 2 Identification of start and end points of reference sites using tape

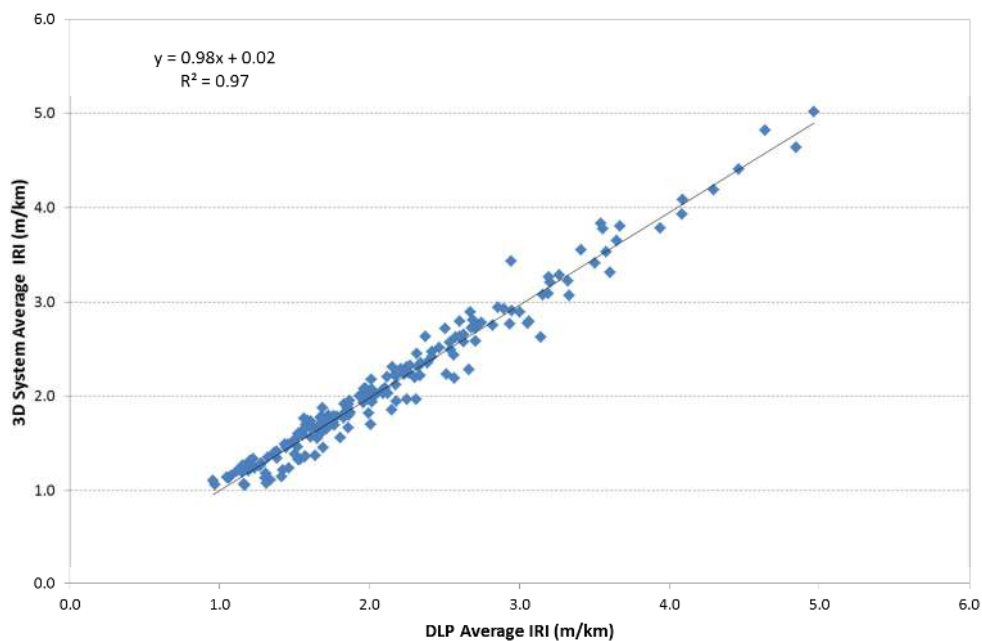
The resulting correlation between the 3D system and the reference data set from the DLP is shown in FIGURE 3.

FIGURE 3 Correlation between DLP and 3D system roughness measurements

The test method states that the 3D system must meet two criteria if it is to pass the validation check:

1. The calculated coefficient of determination, r^2 , between the two data sets must be at least 0.95.
2. The overall average of the percentage differences for each 100 m section between the average of the five runs of the 3D system and the corresponding reference must be less than or equal to 5%.

The results of the validation exercise are shown in TABLE 1. According to the limits specified in the test method the 3D system passed the validation.

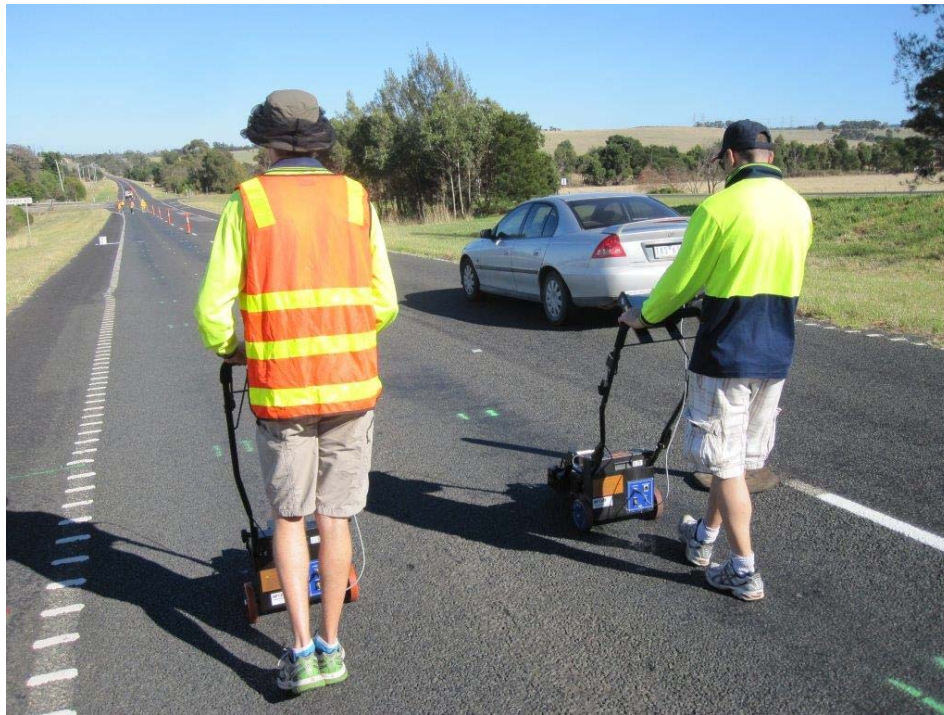
Two Walking Profilers were used to collect the ground truth IRI measurements as shown in FIGURE 4. The data was collected in each wheel path at each of the five sites. Two runs were made in each wheel path and the results averaged. This data was collected in March 2013.

**FIGURE 4 Ground truth data collection with reference device**

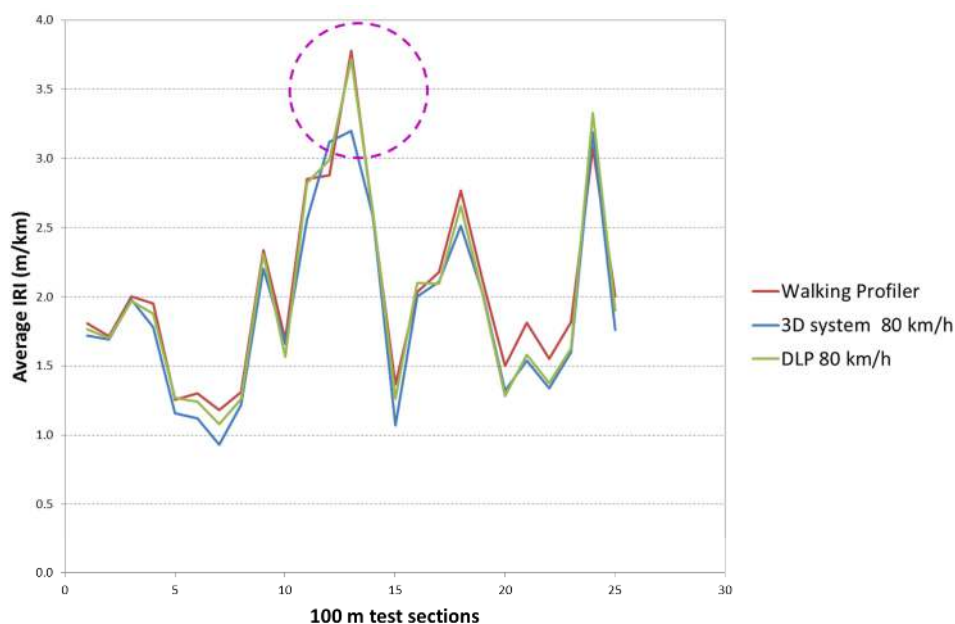
FIGURE 5 Average IRI results from test sections - Walking Profiler, 3D system and DLP

As shown in FIGURE 5 the average IRI values reported by both the 3D system and the DLP were often lower than the Walking Profiler. It is possible that the difference is due to a variation in tracking between the two systems and the reference device.³

As circled in FIGURE 5 there is also one 100 m section where there is a significant difference in the IRI values recorded by the Walking Profiler and the 3D system. However, the same difference was not present in the DLP data which agreed with the reference device. A detailed investigation of this 100 m section is yet to be undertaken but there is a thought that the location of the longitudinal profile measurements made by the 3D system may have been slightly offset (narrower or wider) than those of the DLP meaning it did not pick up the pavement defect(s) or profile variation that the DLP and Walking Profiler both did.
