Automated Pavement Condition Assessment Using Laser Crack Measurement System (LCMS) on Airfield Pavements in Ireland.

The paper examines and compares the pavement condition results obtained from the manual, video and LCMS data collection methods, and outlines the findings in using LCMS technology to automatically identify, geo-locate and graphically report pavement condition and distress data for airfield pavements.

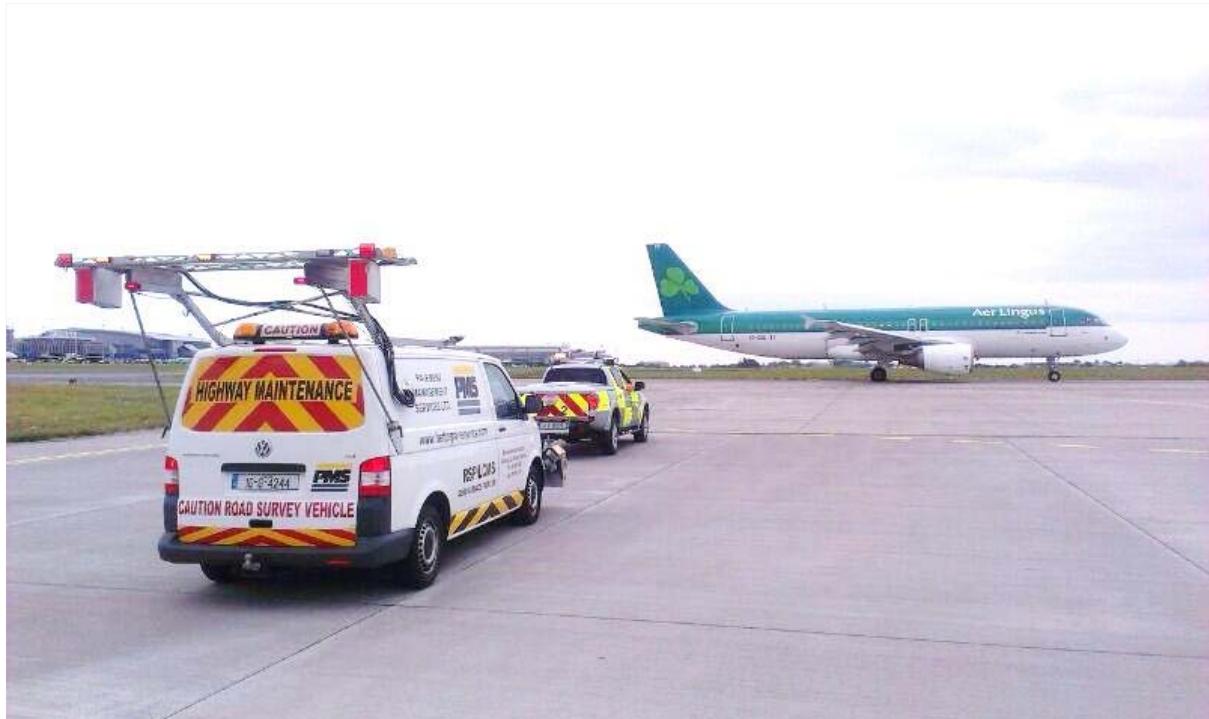
FIGURE 1 High-Speed LCMS Survey Vehicle at Dublin Airport.

The LCMS, developed by Pavometrics Systems Inc., Canada, is a 3D laser-based, high-speed and high-resolution transverse profiling system. The LCMS consists of two downward facing high-speed line scan cameras and high power laser line projectors to acquire both 2D images and high-resolution 3D profiles of the pavement surface. Lasers are projected on to the pavement surface to be inspected and its image is captured by the cameras. Figure 1 shows the LCMS in operation at Dublin Airport.

The LCMS is mounted on the rear of a Road Surface Profiler (RSP) survey vehicle. In addition to the LCMS imagery, the RSP provides a multi-purpose data collection system for continuous high-speed measurement of a variety of other pavement performance data including longitudinal profile (including IRI, International Roughness Index), transverse profile (rut depths), surface macrotexture (expressed as MPD, Mean Profile Depth), geometrics, forward-view imaging and positioning data. The data is chainage-referenced using a highly accurate DMI, and geo-referenced using a high-specification GPS device and Inertial Navigation System (INS).

The LCMS acquires 3D data by measuring the distance from the sensor to the surface for every sampled point on the pavement. The sensors simultaneously acquire both 3D “Range” (height of each pixel) and “Intensity” (the intensity of the reflected light for each pixel) images of the scanned surface (8). The two fully synchronized 3D laser profiles can capture a continuous image of the pavement profile with 1 millimetre/pixel resolution. Each profile consists of up to 4160 data points giving full 4-metre width 3D profiles of the pavement. The system can be operated in full daylight or in night time conditions. The LCMS can be driven at speeds of up to 120 km/hr (about 75 mph), but is typically operated in Ireland at 70 to 80 km/hr (about 45 to 50 mph).

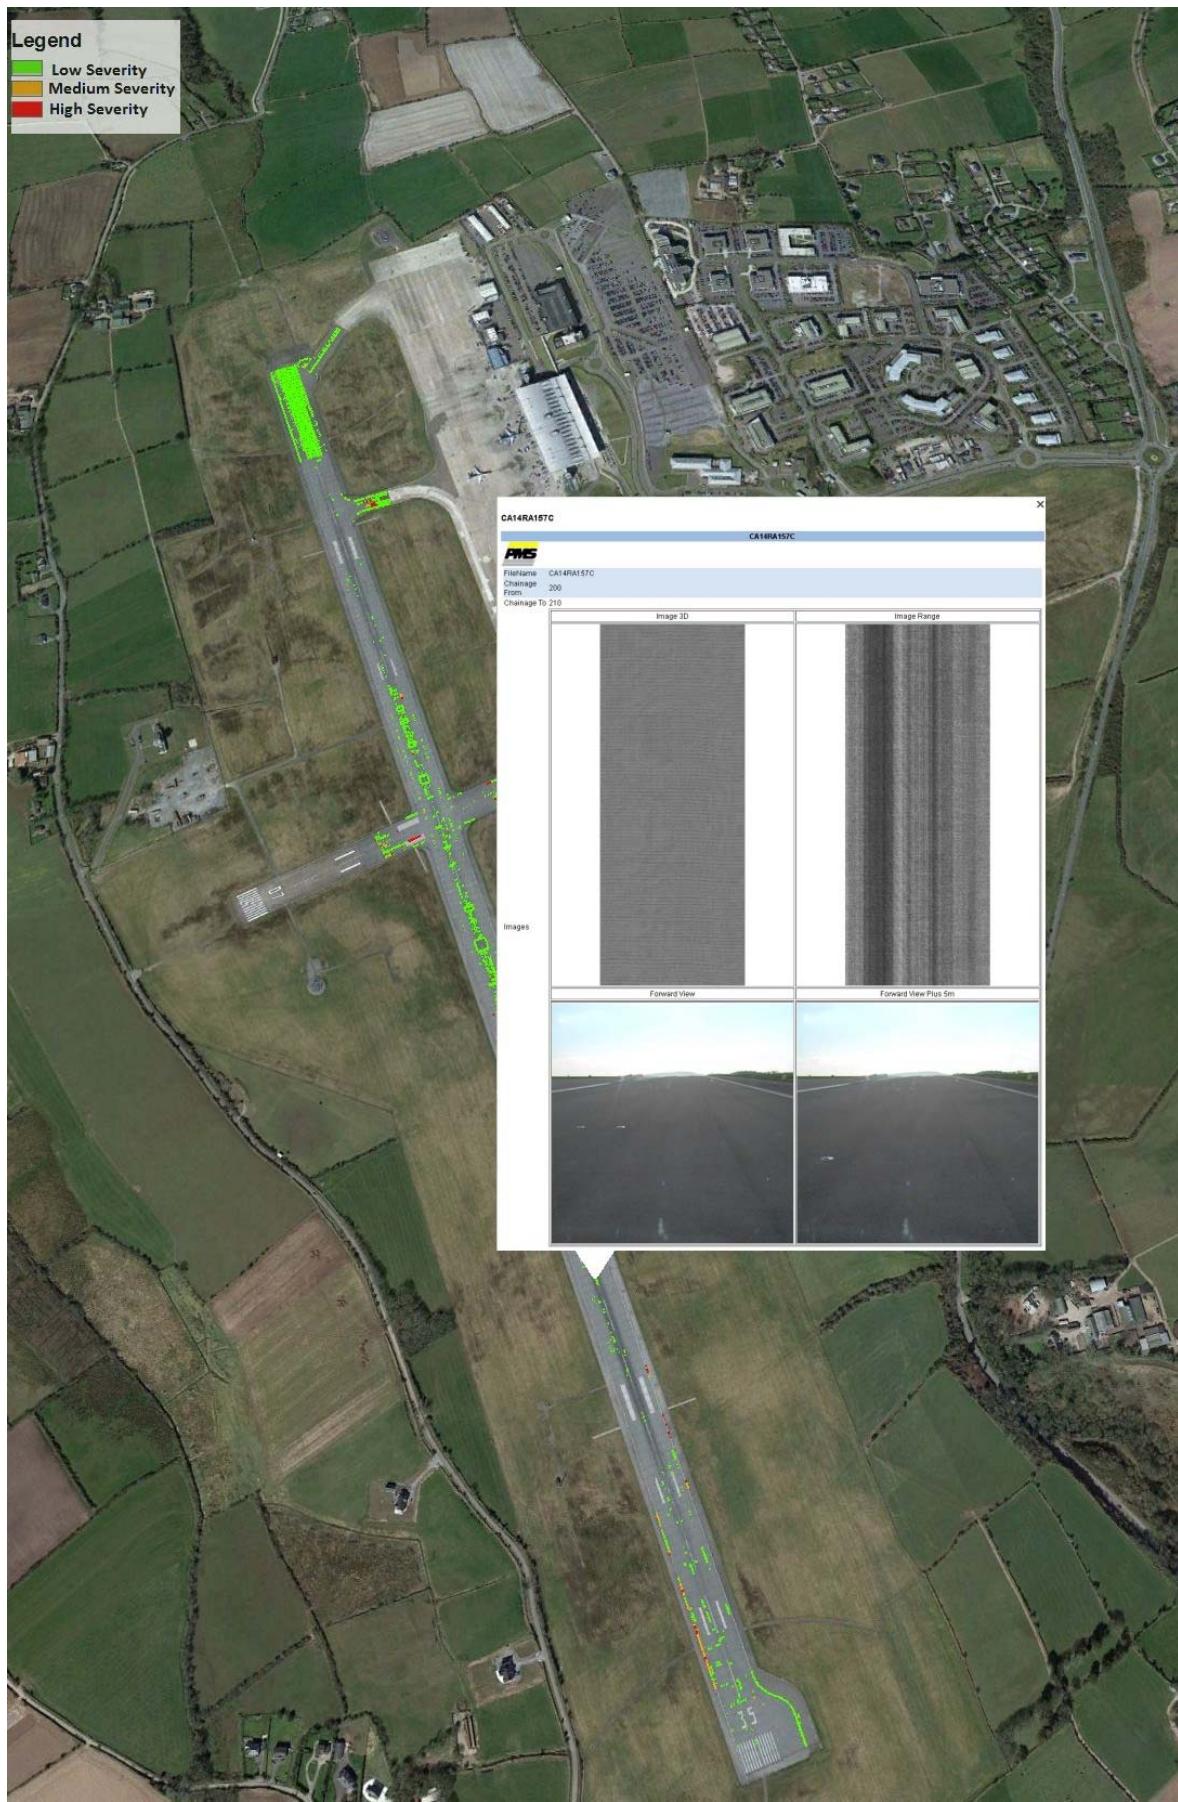
FIGURE 10 Google Earth Thematic for Runway 17/35, Cork Airport.

The forward-view, range and intensity images were output as JPEG images from the LCMS survey for use in the graphical reporting of the data. The imagery, distress data and PCI from the automated LCMS survey were graphically reported using colour-coded theatics in ArcGIS and Google Earth GIS formats, and the detailed distress data was also mapped in AutoCAD layers. The ArcGIS was reported using a .shp (shapefile) format. The Google Earth output was reported using a .kmz file, and the AutoCAD data was reported in layers using a .dwg file format. The data was reported for each 100m x 3m sample unit on both runways. The colour-coded theatics in ArcGIS and Google Earth reported the area and linear distresses in separate layers using a RAG (red, amber, green) colour coding depending on the level of severity. By clicking on individual sample units, the PCI data, detailed distress data, and the forward view and LCMS imagery is displayed using pop up links. Figure 10 shows a sample of the graphical output in Google Earth.
