# AUTOMATED DETECTION OF SEALED CRACKS USING 2D AND 3D ROAD SURFACE DATA

<sup>1</sup>Pavemetrics Systems inc., Canada

**Abstract:** Reliable cracking data has proven difficult and expensive to obtain using cameras and video systems because of the lack of good automated 2D image processing crack detection algorithms. To solve this problem, 3D technology such as the LCMS (Laser Crack Measurement System) has been used to obtain automated reliable and repeatable cracking data.

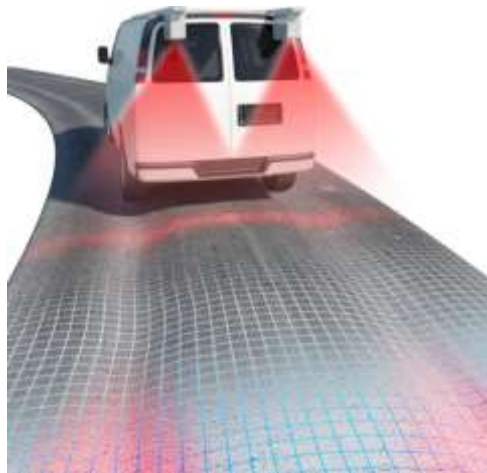
*Figure 1. LCMS on an inspection vehicle.*

The sensors used with the LCMS system are 3D laser profilers that use high power laser line projectors, custom filters and a camera as the detector. The light strip is projected onto the pavement and its image is captured by the camera. The shape of the pavement is acquired as the inspection vehicle travels along the road using a signal from an odometer to synchronize the sensor acquisition (see figure 1). All the images coming from the cameras are sent to the frame grabber to be digitized and then processed by the CPU. Saving the raw images would imply storing nearly 30Gb per kilometer at 100 km/h but using lossless data compression algorithms on the 3D data and fast JPEG compression on the intensity data brings the data rate down to a very manageable 20Mb/s or 720Mb/km. The critical specifications for the LCMS system can be found on table I. It is important to note that in addition to the 3D profiles the LCMS acquires the intensity of the reflection of the laser at each 3D point thus creating an intensity 2D image of the pavement while simultaneously measuring the shape. Figure 2 shows range (distance) image and intensity (2D) data acquired from the LCMS. A 3D image can be generated from the range and intensity data as shown.

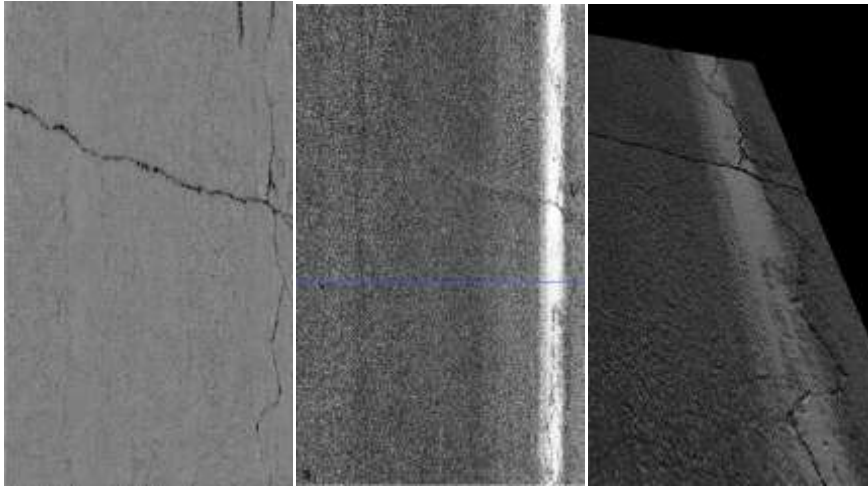
Figure 2. LCMS data type – Range (left) – Intensity (center) – 3D merged (right).

The 3D data acquired by the LCMS system measures the distance from the sensor to the surface for every sampled point on the road. The previous image (above left) shows a range data image acquired by the sensors. In this image, elevation has been converted to a gray level. The darker the point, the lower is the surface. In a range image the height can vary along the cross section of the road. The areas in the wheel path can be deeper than the sides and thus appear darker this would correspond to the presence of ruts. Height variations can also be observed in the longitudinal direction due to variations in longitudinal profiles of the road causing movements in the suspension of the vehicle holding the sensors. These large-scale height variations correspond to the low-spatial frequency content of the range. The first step in range analysis is to separate the high frequency content from the low

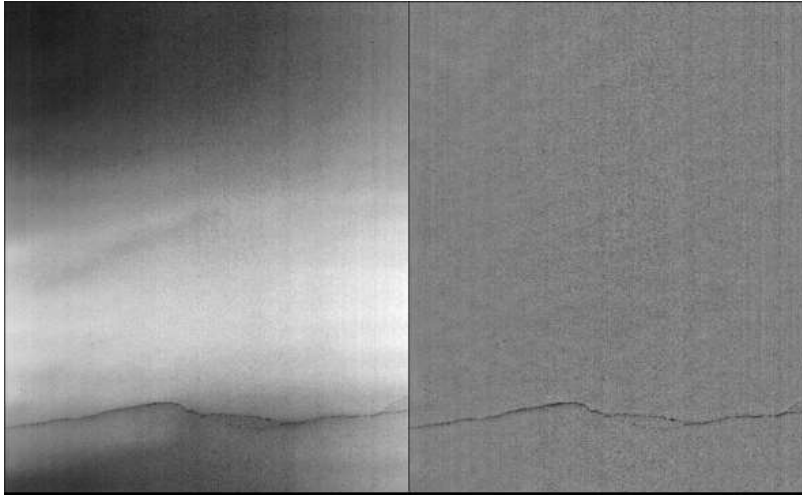
Figure 3: (a) Range (raw) and (b) Range (rectified) images

one. This is performed using a specially designed filter. Figure 3b shows the result of this process. The low frequency part is what can be referred to as the mean surface. The high-frequency part clearly shows the presence of surface defects (cracks) and texture. Once separated, both frequency parts are then used as an input to the various feature detection algorithms the high frequency component is called the rectified range image as shown below.

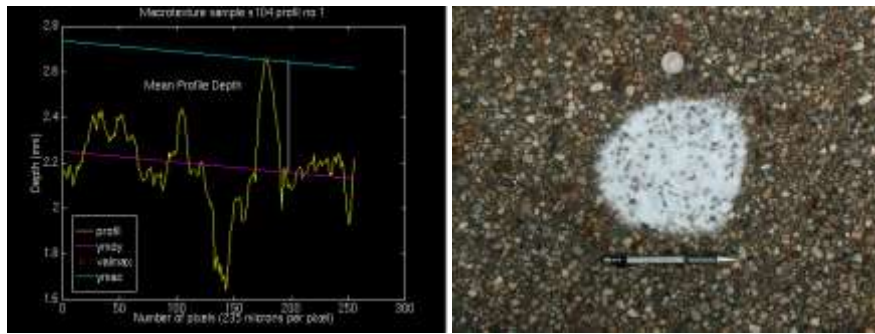
Figure 4. MPD vs sand patch.

Macrotexture is important for several reasons, for example it can help estimate the tire/road friction level, water runoff and aquaplaning conditions and tire/road noise levels produced just to name a few. Macrotexture can be evaluated by applying the ASTM 1845-01 norm [6]. This standard requires the calculation of the mean profile depth (MPD). To calculate the MPD, the profile is divided into small (10cm) segments and for each segment a linear regression is performed on the data. The MPD is then computed as the difference between the highest point on the profile and the average fitted line for the considered portion. MPD is the only way possible to evaluate texture using standard single point (64 kHz) laser sensors. The LCMS however acquires sufficiently dense 3D data to not only measure standard MPD but also to evaluate MTD texture (mean texture depth) using a digital model of the sand patch method (ASTM E965) [7] as shown on figure 4.

The digital sand patch model MTD calculates the volume of the voids in the road surface that would be occupied by the sand (from the sand patch method) divided by a surface area. The digital sand patch method implemented allows texture to be evaluated continuously over the complete road surface instead of measuring only a single point inside a wheel path. The MTD results can be mapped into road surface texture image where the color corresponds to texture levels. In this example bleeding or flushing on the road surface corresponds to areas of very low MTD (0.2mm) shown in blue (figure 5).

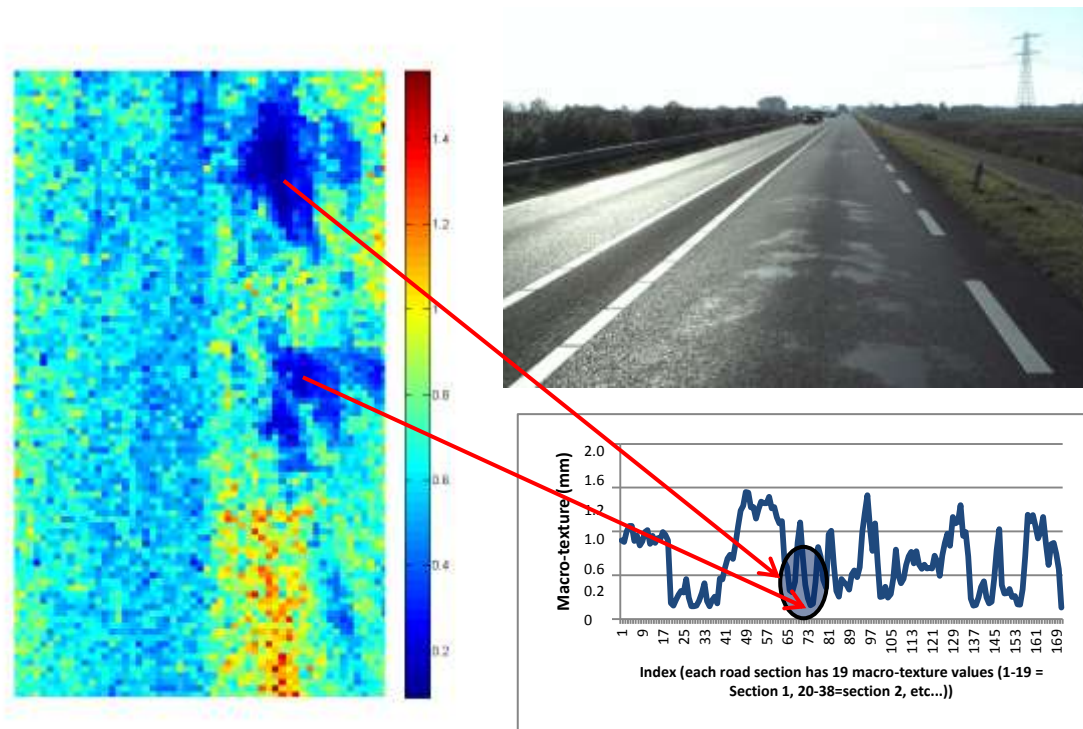
*Figure 5. Texture (MTD) map of a road section (blue is low texture)*

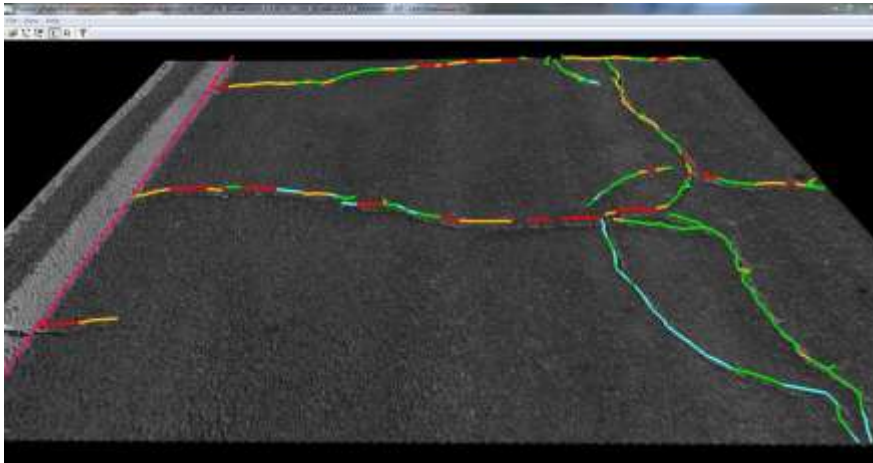
Figure 6. Example crack detection results (severity = color code).

Although the basis of 3D crack detection is finding the crack points that are below the road surface, detecting cracks reliably is far more complex than applying a threshold on a range image. As mentioned previously the 3D data needs to be rectified to remove the effects of rutting and vehicle movements. Macrottexture is also a problem; road surfaces have very variable macrottexture from one section to the next and even from one side of the lane to the other. In general to detect a crack using 3D techniques the majority of the crack points must be below the average depth of the macro-texture of the road surface. For example, on roads with weak macrottexture we can hope to detect very small cracks which will be harder to detect on more highly textured surfaces. It is thus necessary to evaluate and to adapt the processing operations based on the texture and type of road surface. Once the detection operation is performed, a binary image is obtained where the remaining active pixels are potential cracks. This binary image is then filtered to remove many of the false detections which are caused by asperities and other features in the road surface which are not cracks on the pavement. At this point in the processing, most of the remaining pixels can correctly be identified to existing cracks, however many of these crack segments need to be joined together to avoid multiple detections of the same crack. After the detection process, the next step consists in the characterization of the cracks. The severity level of a crack is determined by evaluating its average width (opening) typically cracks will be separated in low, medium and high severity levels.

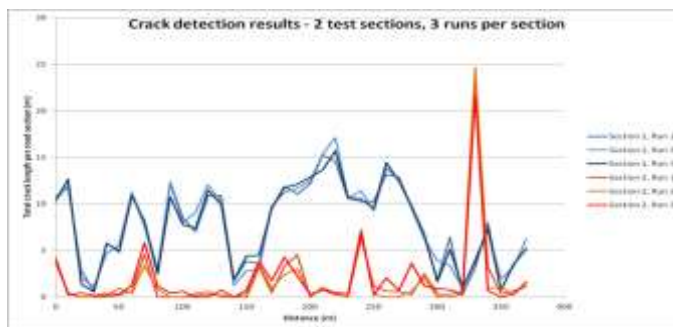
Figure 7. Repeatability results (3 passes) on two MTQ road sections.

The LCMS system has been used to survey millions of lane kilometers over the past 6 years and has demonstrated its ability to automatically detect cracks [3]. Independent 3rd party users and DOTs have also evaluated the system [8] [9]. Typical results include repeatability tests that usually attain 95%+ in many different conditions.

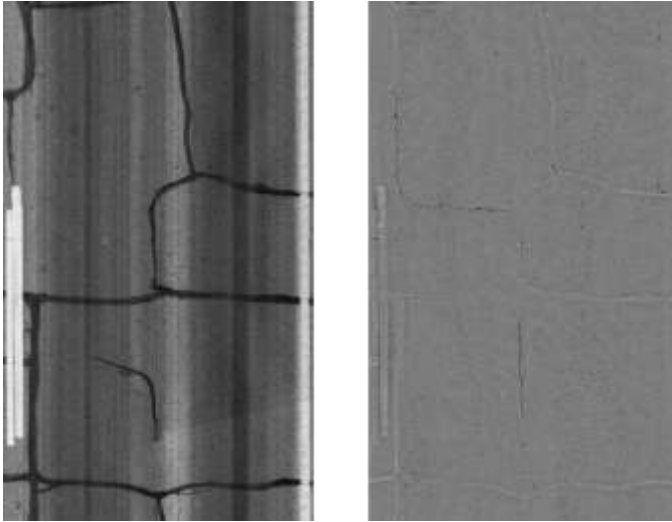
*Figure 8.* Example sealed cracks: Intensity image (left) Rectified range (right)

The images (Figure 8) below demonstrate what the majority of sealed cracks look like, i.e. the sealed cracks are very dark in the images due to the black color of the sealant. This makes these cracks very visible in the intensity images (high contrast) and the fact that they are sealed makes them virtually ‘invisible’ in the range images compared to the unsealed cracks that appear as dark lines in the rectified range images.

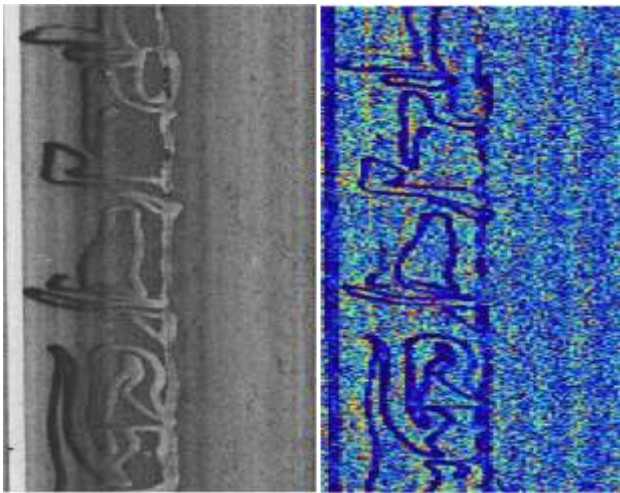
*Figure 9.* Example sealed cracks: a) Intensity image b)Texture map

However, the next images (Figure 9a) shown below demonstrates that in some cases the sealed cracks do not appear dark, in fact their color can vary greatly ranging from black to shiny white. Thus intensity alone cannot be used as a reliable indicator of their presence.

texture measurements as the surface of a sealed crack is very smooth (low MPD values) as the sealant used not only fills the crack but also the air voids of the asphalt texture. Figure 9b shows the texture color map of the roadsection with sealed cracks it is clear that these areas show very low texture MTD values (blue).

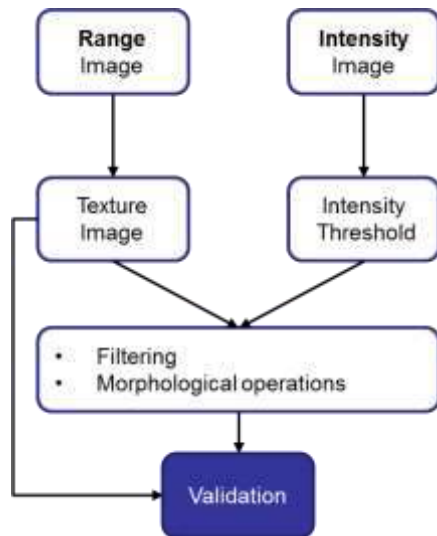
Figure 2. Main steps in the detection of sealed cracks

Figure 10 describes the main steps in the algorithm implemented. This algorithm uses in fact both intensity and range (texture) data to detect sealed cracks. The intensity image analysis algorithm looks for dark or light areas that are of different color than the surrounding background (road surface) and flags these areas as possible sealed cracks. As mentioned above the range data 3D texture is evaluated (MTD) and areas of low texture are detected as possible sealed cracks. All candidate areas are then evaluated as to their shape conformity to make sure they are crack shaped i.e. much longer than wide and with a width ranging up to a few centimeters. A final validation is done to make sure all remaining sealed crack candidate areas have both appropriate texture and color characteristics before being accepted.

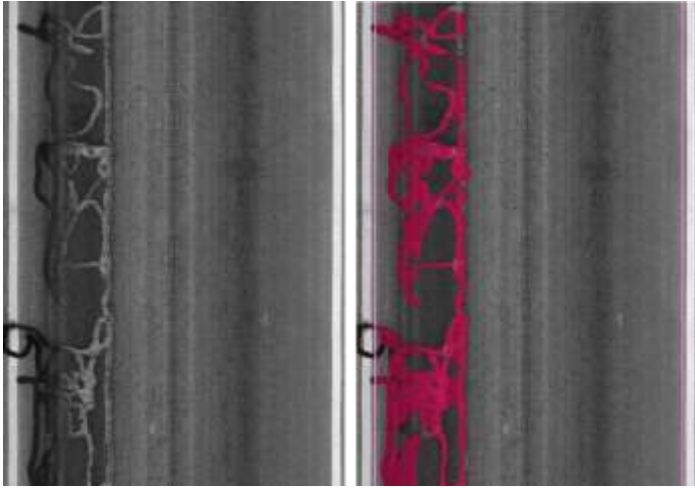
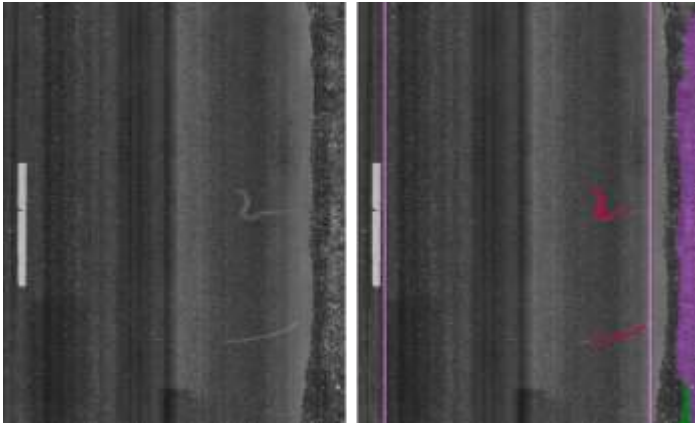
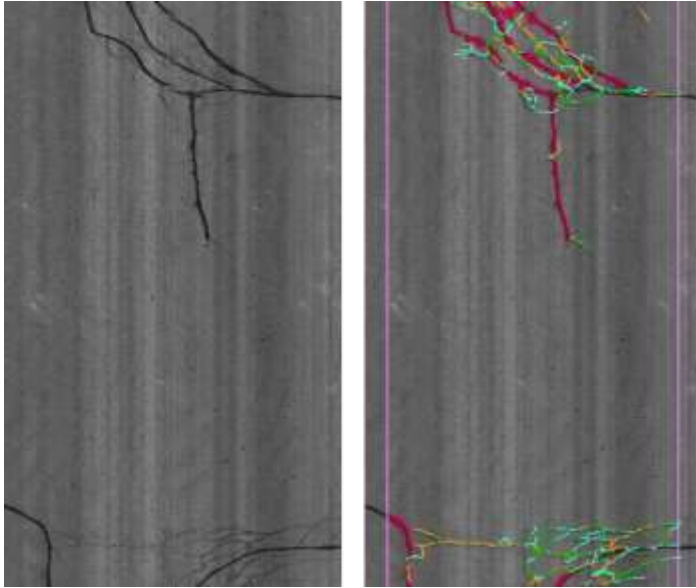
*Figure 3. Three examples of sealed cracks detection on road surfaces (results in red)*
