# 3D TECHNOLOGY FOR MANAGING PAVEMENTS

Principal Consultant, [ARRB Group](#), Victoria, Australia

## Abstract

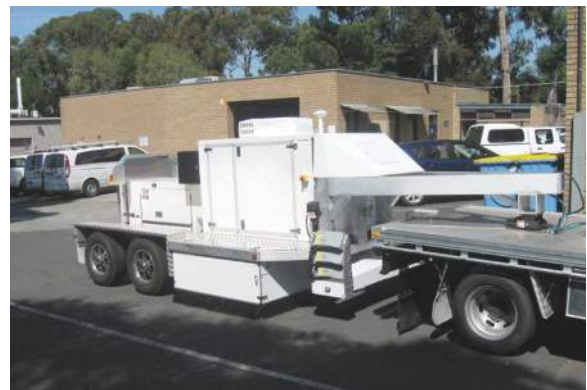
The RoadCrack system was initially mounted on a truck and was much larger than most common survey vehicles but in 2011 the system was modified and upgraded by ARRB so that it could be installed on a much smaller 5th wheel trailer platform which is shown in Figure 1.

Figure 1: RoadCrack system – new trailer version

One of the main benefits of the RoadCrack system is that it can generate cracking outputs in real time whilst travelling at highway speed. This alleviates the need to store large volumes of imaging data for post-processing and it also means that the cracking results are immediately available at the end of each survey run. To achieve this outcome, the system relies upon a powerful lighting system and specifically developed crack identification algorithms.

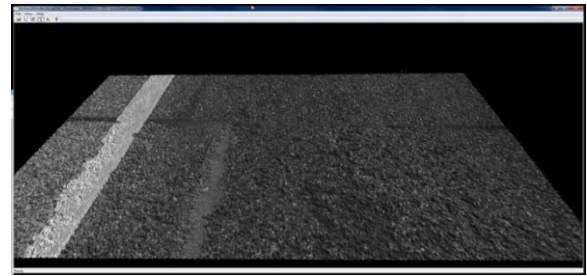
- Ravelling – this is defined as the ‘progressive disintegration of the pavement surface by loss of both binder and aggregates’ (Austroads 1987). The ACD identifies ravelled surfaces by calculating the volume of aggregate loss over

the area. The 3D picture shown in Figure 10 shows an example of ravelling identified by the ACD.

Figure 10: 3D image of ravelling produced by ACD (picture courtesy of Pavemetrics)
